# Manhole Inspection Summary

Manhole # S17GG1008MH

**Location** Address: **2404 SHIRLEY AVE**

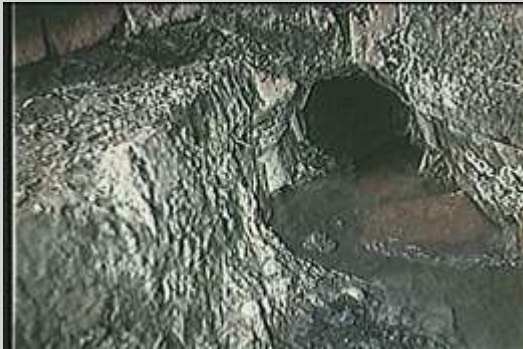
### 8 in. Circular Gravity Sewer Pipe Out @ 12 O'Clock

Invert Depth: **4.05** (ft.) Flow Characteristics: **Fast**

Deposits: ☒ None ☐ Mud ☐ Sludge ☐ Debris ☐ Grease

Infiltration: **None** Pipe Seal Cond: **Unknown**

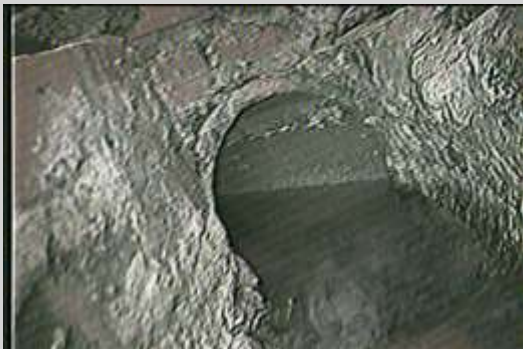
### 8 in. Circular Gravity Sewer Pipe In @ 4 O'Clock

Infiltration: **None** Pipe Seal Cond: **Unknown**
